I-94 East-West Corridor Study Visual Impact Assessment

PREPARED BY: Mark Greenig/CH2M HILL, Ben Goldsworthy/CH2M HILL
COPIES: File
DATE: September, 2014

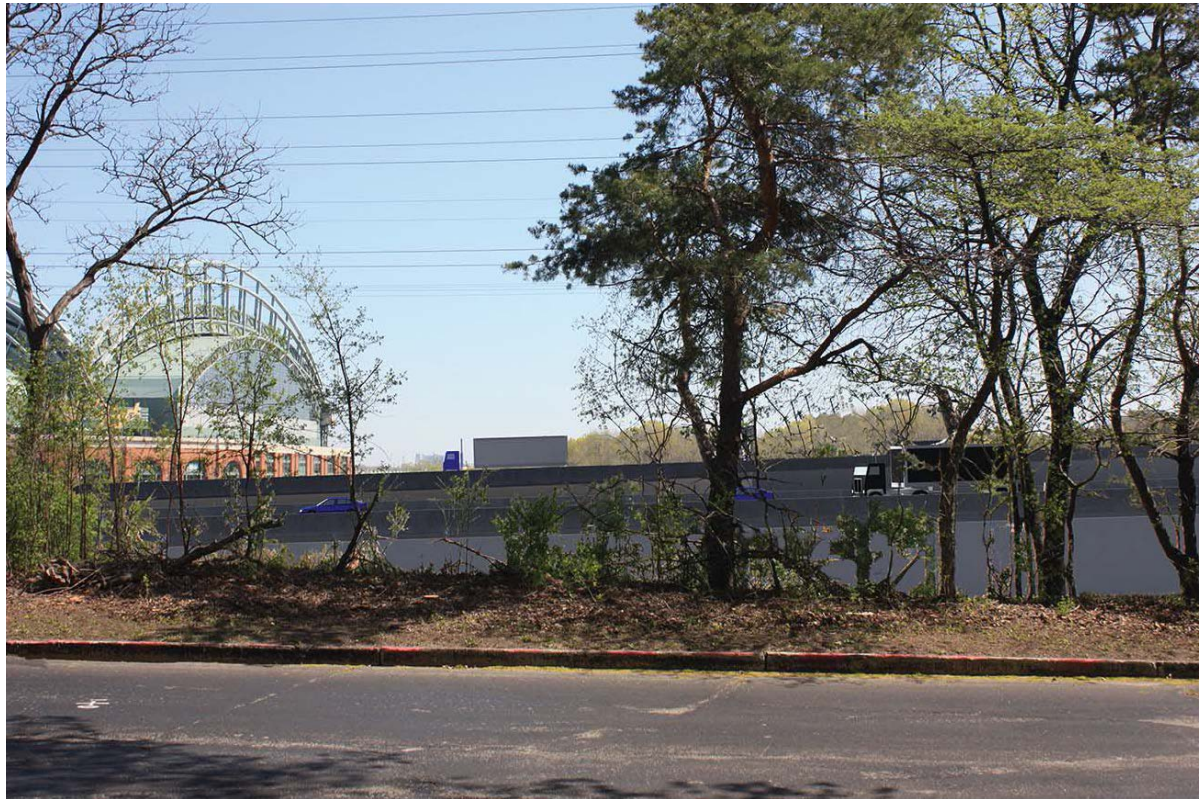
Simulation: Modified Alternative C5 (Double Deck) All Up option.

Visual Resource Survey:		Alt C5 - All Up Option	
KOP Location: N. Story Hill Parkway (west)		Viewpoint: KOP 7	
Vividness			
Feature	Score*	Notes	
Landform	2.5	The elevated structure will block views of the buildings in the valley below I-94 and the lower slopes of the hillsides beyond, particularly during leaf-off condtions.	
Vegetation	4	Vegetation on hillsides to the southeast somewhat blocked by elevated structure during leaf-off conditions.	
Water Feature	NA		
Human-Made	3.5	The lower part of Miller Park will be blocked by the elevated structure, as will views of the roofs of commercail-industrial buildings in the valley below I-94.	
Overall	3.3		
Intactness			
Overall	3	Views of the elevated structure would replace views of the roofs of commercail - industrial buildings.	
Unity			
Overall	3	Overall visual unity would be somewhat lowered due to the presence of the elevated structure.	
Overall Visual Quality Score	3.1	Note that the ratings for the C5 - Partial Down Option would be very similar to the ratings for the All-Up option becasue the elevations of the two options would be very similar. The ratings for the Modernization Alternative S2 (system interchange – low-speed, free-flow) and Modernization Alternative S3 (single-point interchange with free-flow ramps from I-94) alternatives would be slighly higher than the All-Up option becasue they would be lower in elevation. The elevated structures associated with the S2 and S3 alternatives and vehicles on them would still be seen (particularly during leaf-off condtions) but would be lower in the view.

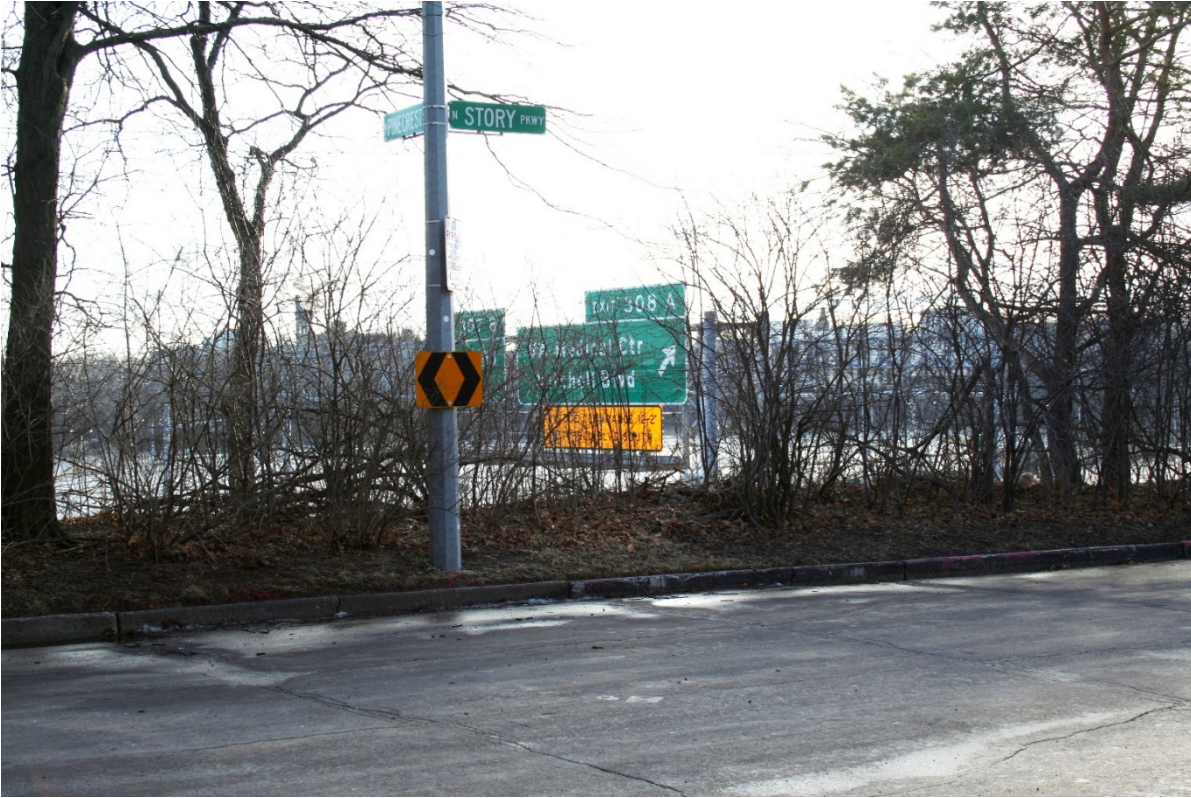
Exhibit B-10. KOP 8

Existing Condition: From Story Parkway and Pinecrest Street looking south at I-94 sign and Miller Park parking areas.

Visual Resource Survey:			Existing Conditions		
KOP Location:		N. Story Hill Parkway and N. Pinecrest Street	Viewpoint:	KOP 8	
Vividness					
Feature	Score*	Notes			
Landform	3	Get an indication that there may be a valley beyond I-94.			
Vegetation	3.5	Parkway side vegetation most prominent.			
Human-Made	3	I-94 signs most visible human-made element.			
Overall	3.2				
Intactness					
Overall	3	A variety of objects seen during leaf-off conditions including I-94 sign, tops of commercial - industrail buildigns in valley beyond I-94.			
Unity					
Overall	3.5				
Overall Visual Quality Score	3.2

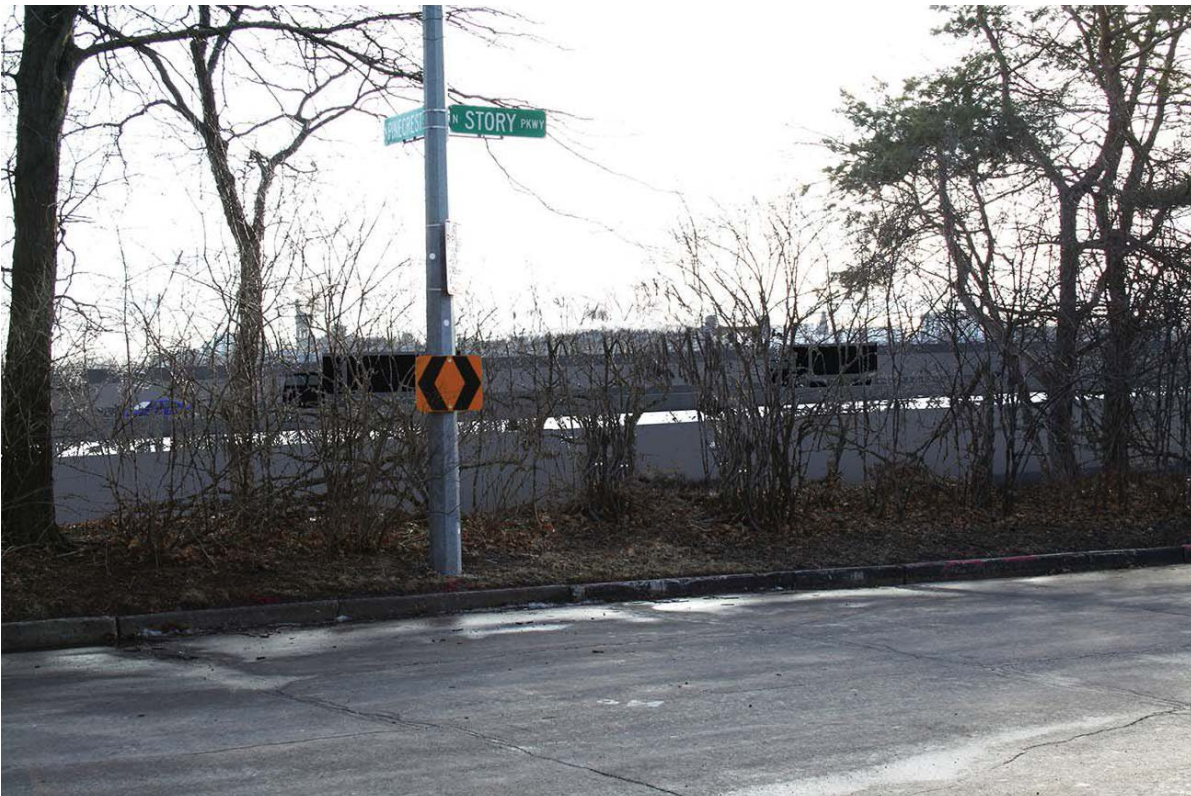
Simulation: Modified Alternative C5 (Double Deck) with All Up option.

Visual Resource Survey:			Alt 5 - All Up Option		
KOP Location:		N. Story Hill Parkway and N. Pinecrest Street	Viewpoint:	KOP 8	
Vividness					
Feature	Score*	Notes			
Landform	3	Little to no change.			
Vegetation	3.5	Vegetation next to parkway not impacted.			
Human-Made	2.5				
Overall	3.0	Elevated structure and vehicles travelling on it could be seen, particularly during leaf-off conditions.			
Intactness					
Overall	3	Little change, I-94 signs no longer seen.			
Unity					
Overall	3	Visual connection with vally below during leaf-off condtions no longer maintained with elevated structure.			
Overall Visual Quality Score	3.0	Note that the ratings for the S2 - Partial Down Option would be very similar to the ratings for the All Up option becasue the elevations of the two options would be very similar. The ratings for the Modernization Alternative S2 (system interchange – low-speed, free-flow) and Modernization Alternative S3 (single-point interchange with free-flow ramps from I-94) alternatives would be slighly higher than the All-Up option becasue they would be lower in elevation. The elevated structures associated with the S2 and S3 alternatives and vehicles on them would still be seen (particularly during leaf-off condtions) but would be lower in the view.

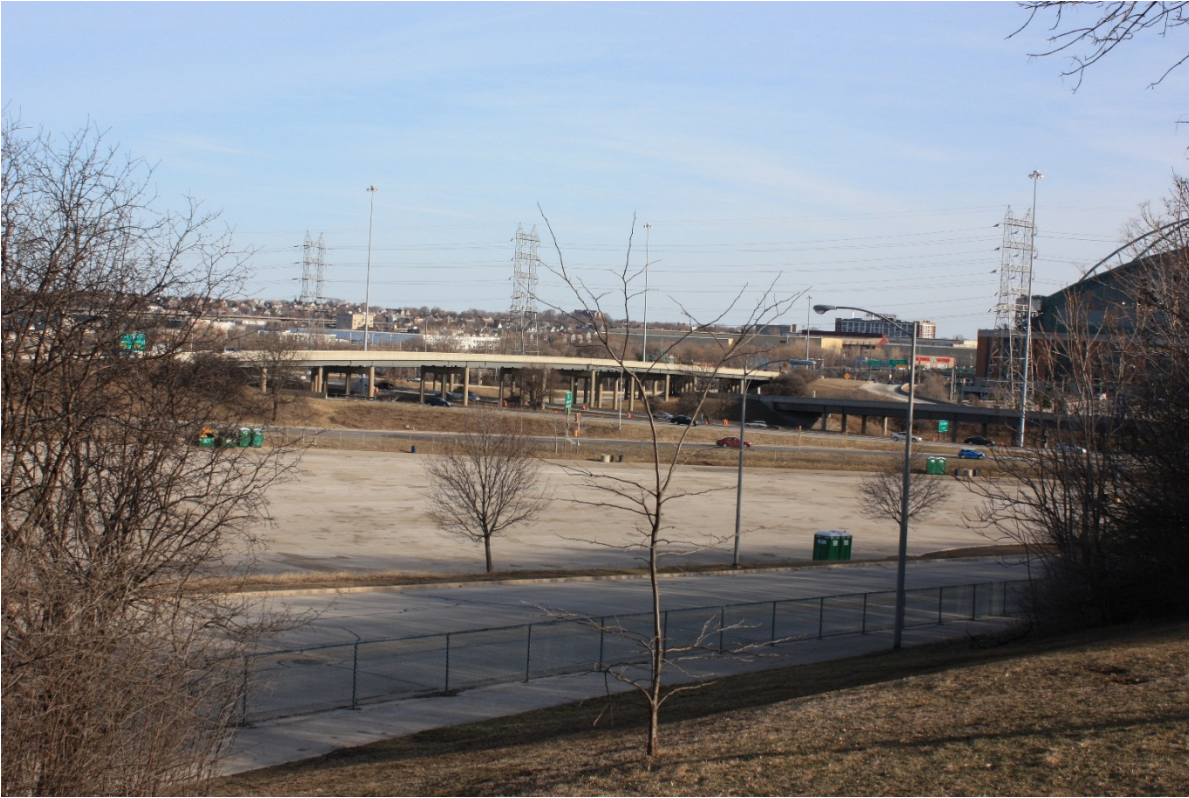
Exhibit B-11. KOP 9

Existing Condition: From N. Story Parkway looking southeast over Yount Drive towards the US 41/I-94 interchange, Miller Park parking areas, and the northeastern edge of Miller Park.

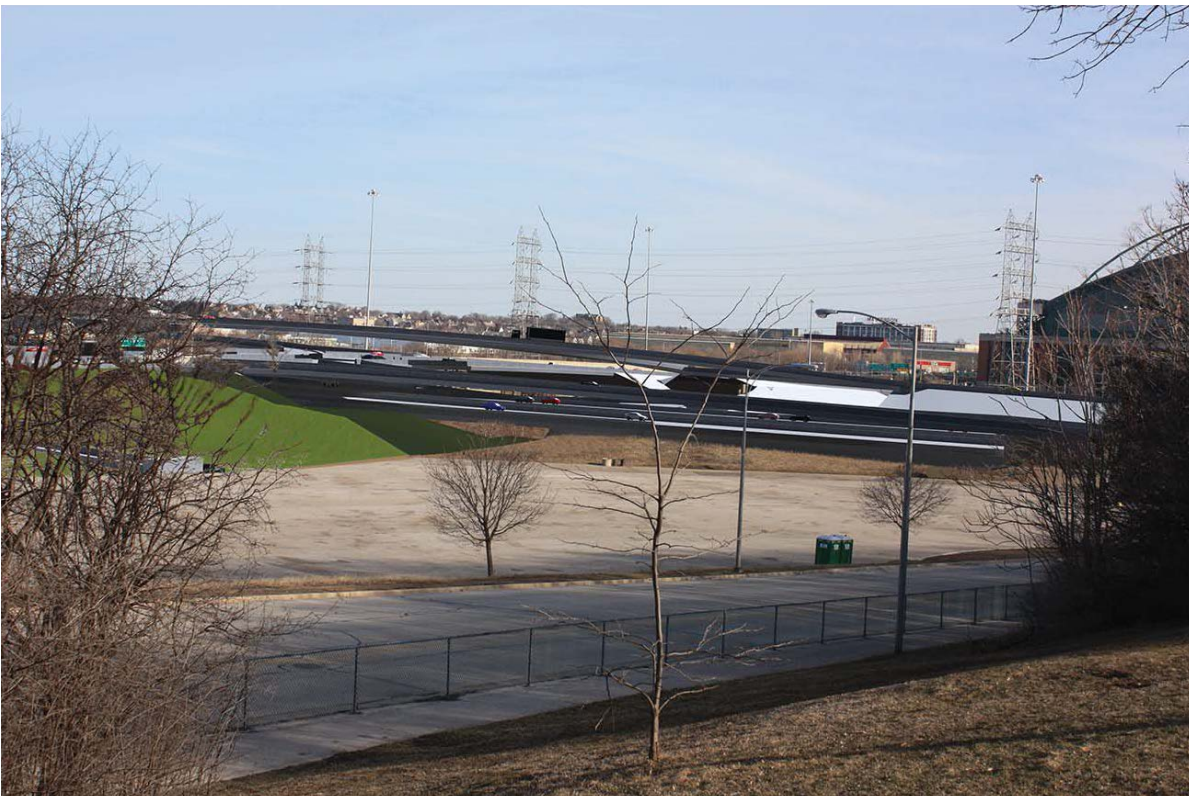
Simulation: Modified Alternative S3 (Single Point).

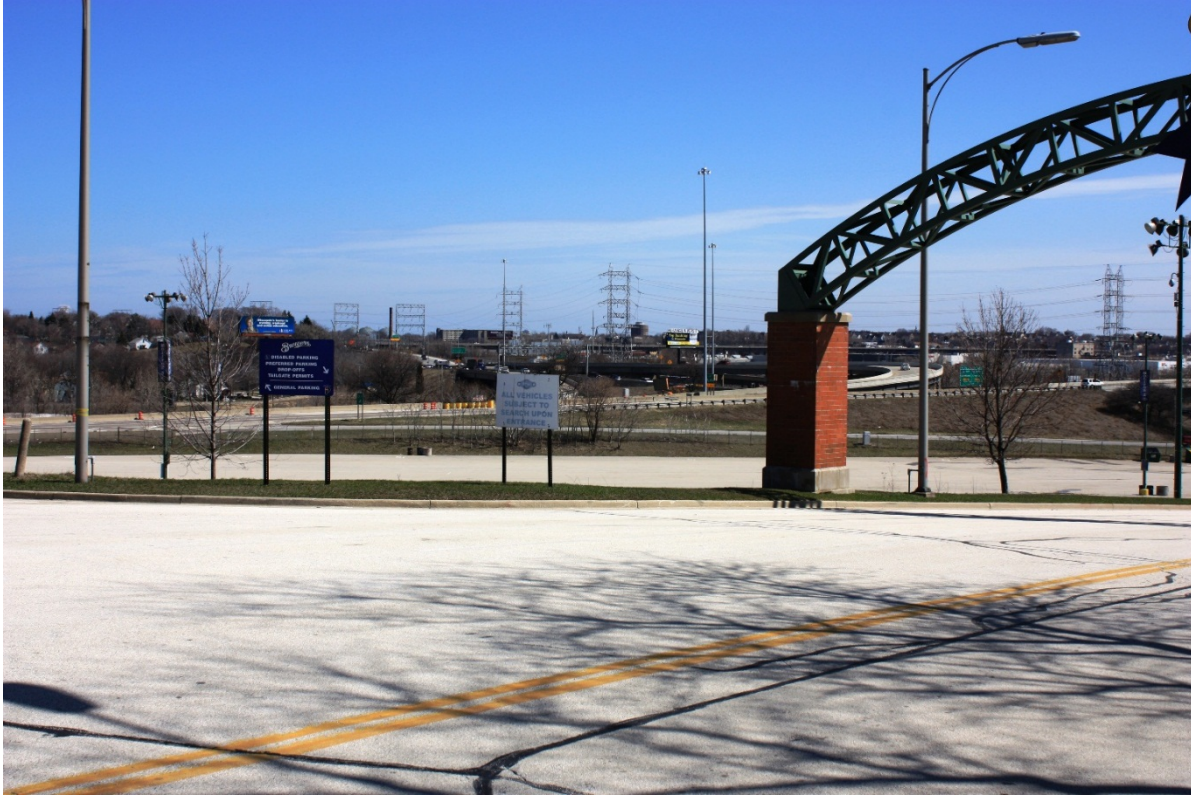
Exhibit B-12. KOP 10

Existing Condition: From Yount Drive (just east of Story Parkway) looking southeast towards entrance to Miller Park, parking areas, and the I-94/US 41 interchange.

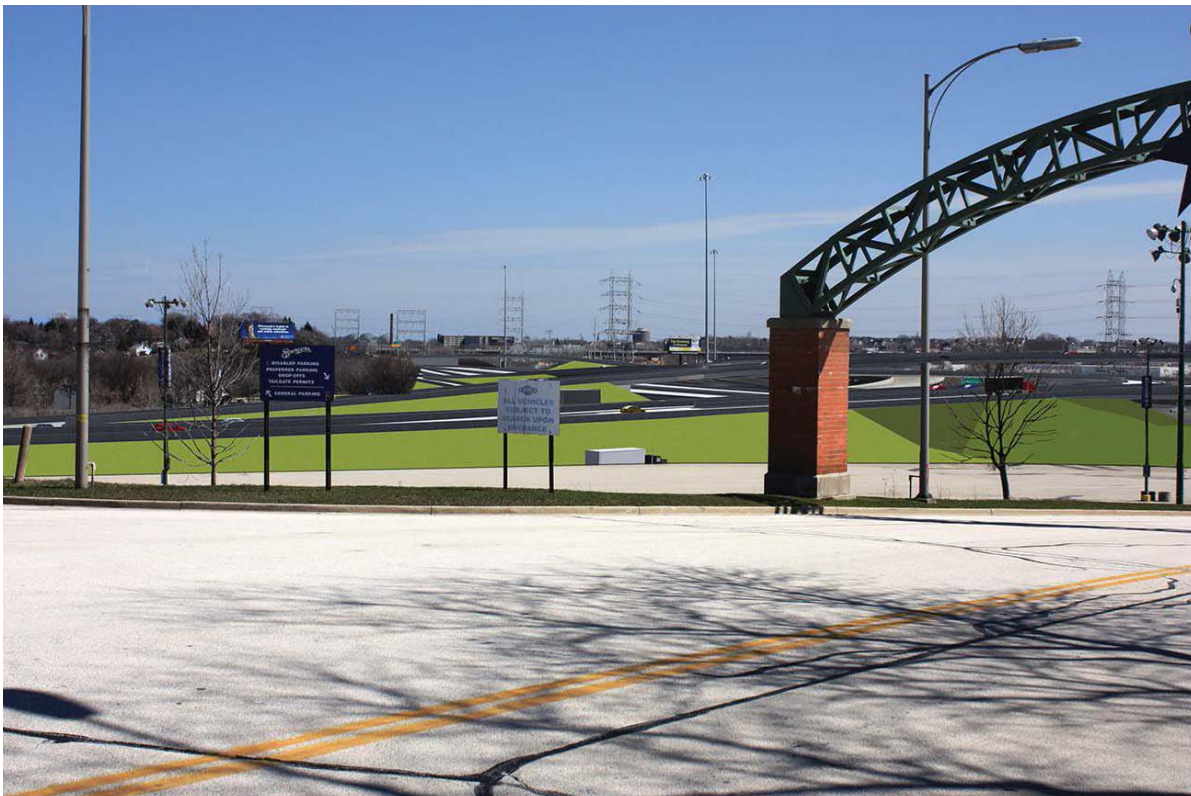
Simulation: Modified Alternative S3 (Single Point).

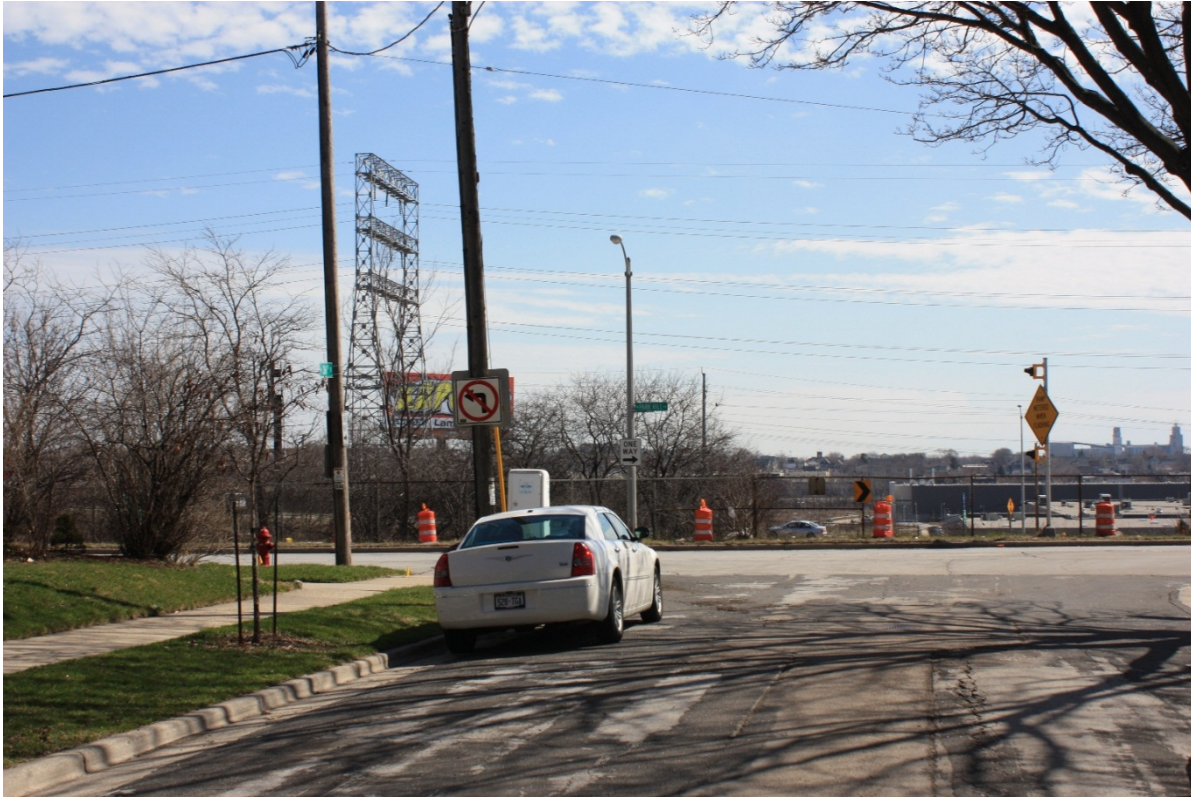
Exhibit B-13. KOP 11

Existing Condition: From 36th Street north of Park Hill Avenue looking south.

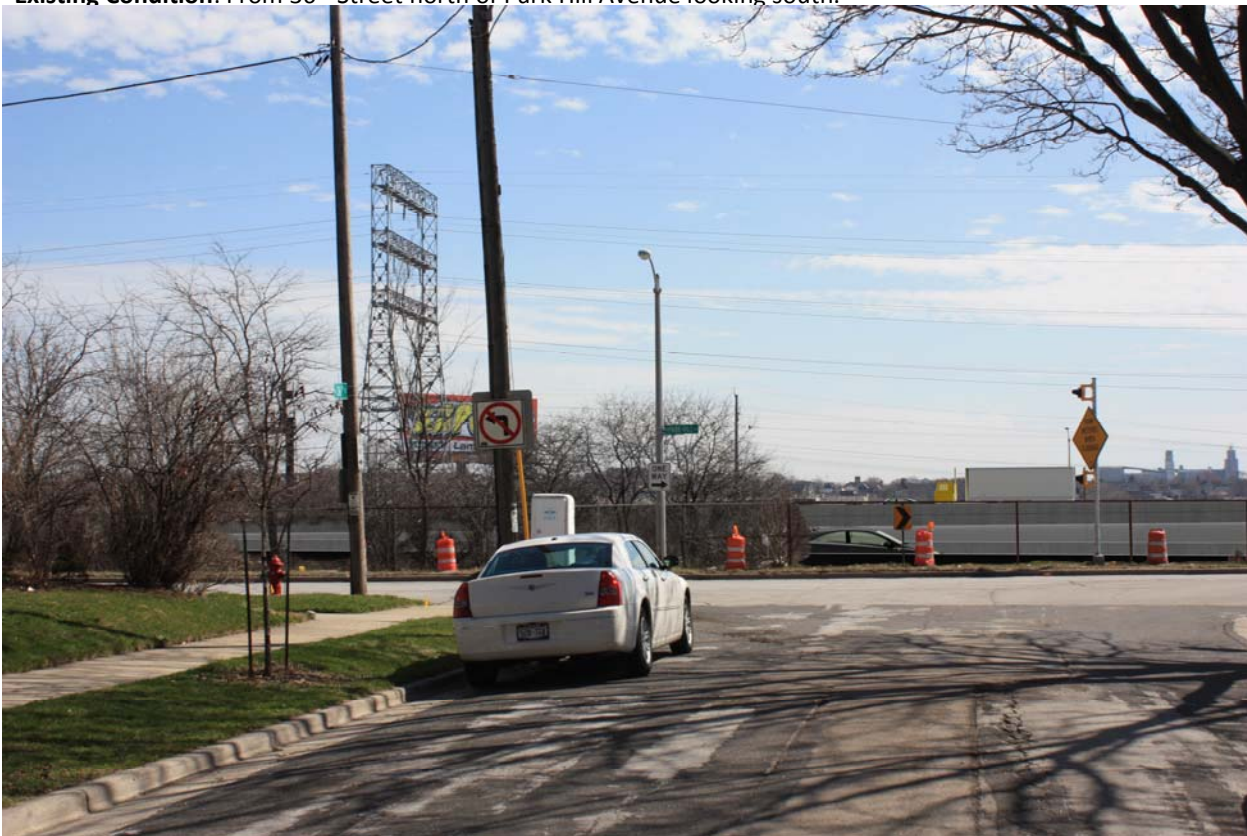
Simulation: Alternative E1 (Braided Ramps).

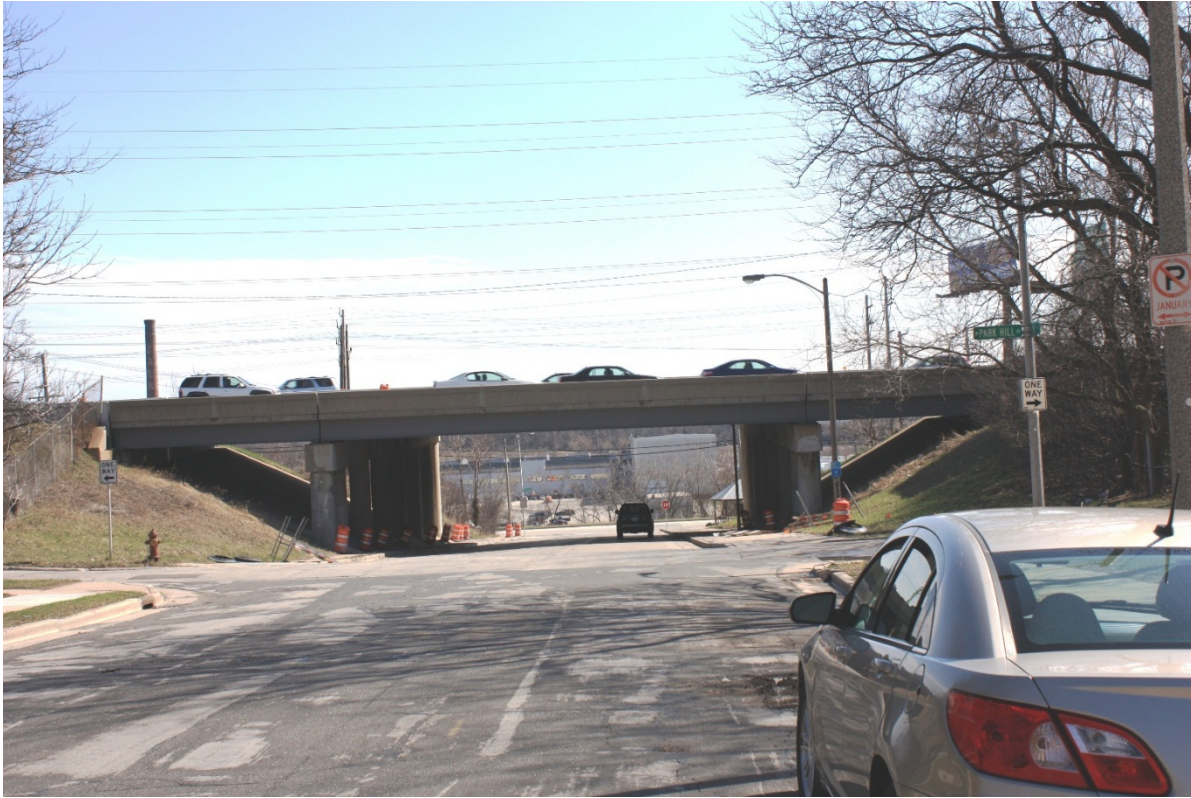
Exhibit B-14. KOP 12

Existing Condition: From 32nd Street north of Park Hill Avenue looking south at I-94 overpass.

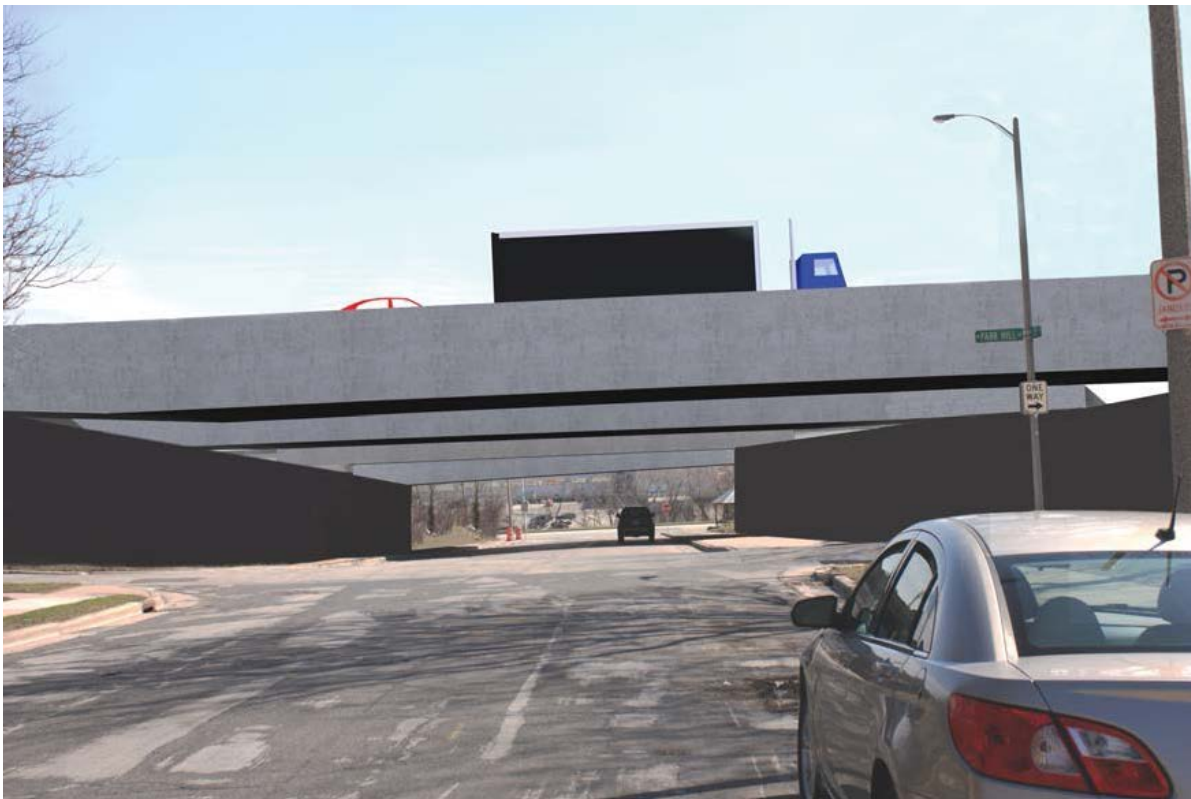
Simulation: Alternative E1 (Braided Ramps).
